Client :	OGDCL
Location :	Qadirpur Gas Plant
Tank Number :	T-9700
Type Of Inspection :	Out of Service Inspection
Job Number:	----
Inspection Date :	03 Sep 2018 To 05 Sep 2018
Job Executed By :	Bakhtiar Ahmed Shams ul Haq Muhammad Akram Danish Vohra Omar Moin

Tank T-9700 has been inspected at Qadirpur for OGDCL .

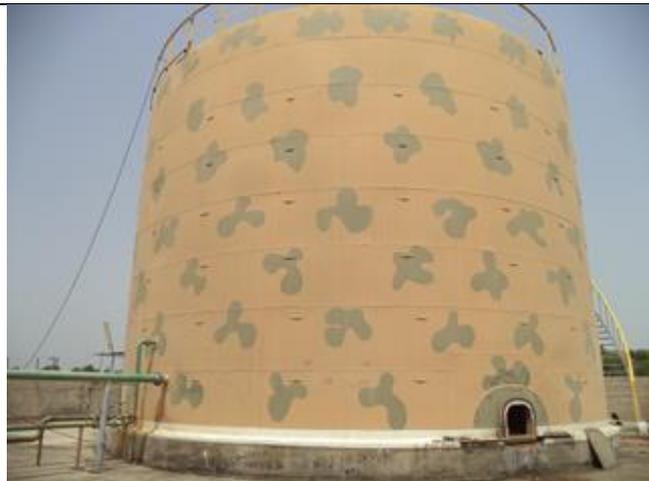
<p>General View of Tank T-9700</p>

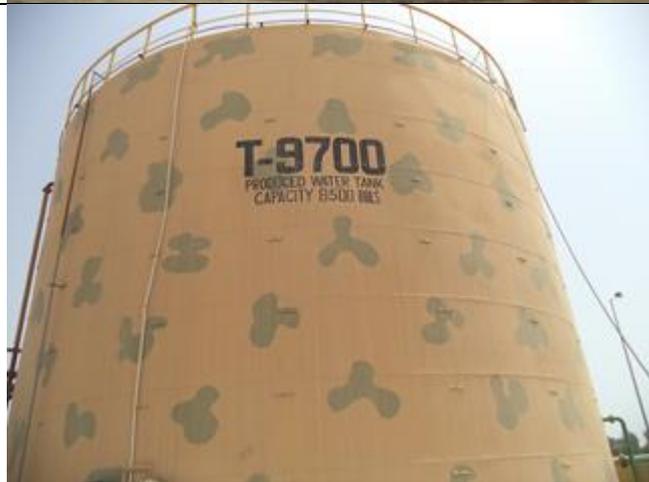
<p>General View of Name plate</p>

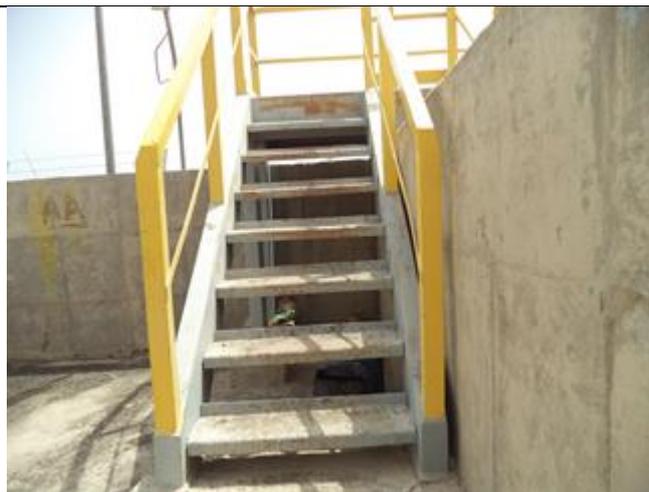
Item	Findings	Recommendations	Repair Priority
1. Access way	There is one access way at south side, minor corrosion and paint failure observed on step pad.	<ul style="list-style-type: none"> To made good surface preparation and recoat as per paint manufacturer' specification. 	Online Or Offline

<p>Access way</p> <p>Finding: There is one. access ways at south side, minor corrosion and paint failure observed on step pad.</p> <p>Recommendation: To made good surface perparation and recoat as per paint manufacturer' specification.</p> <p>Repair Priority: <i>Online Or Offline</i></p>
---	--

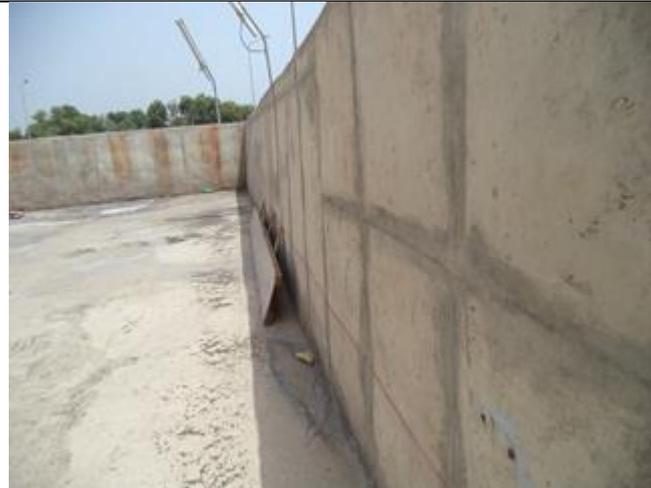
2. Dyke wall	Reinforced Concrete ring wall observed around the tank, found in good condition	<ul style="list-style-type: none"> Nil, just for info 	N/A

<p>Dyke wall</p> <p>Finding: Reinforced Concrete ring wall observed around the tank, found in good condition</p> <p>Recommendation: Nil, just for info</p> <p>Repair Priority: N/A</p>

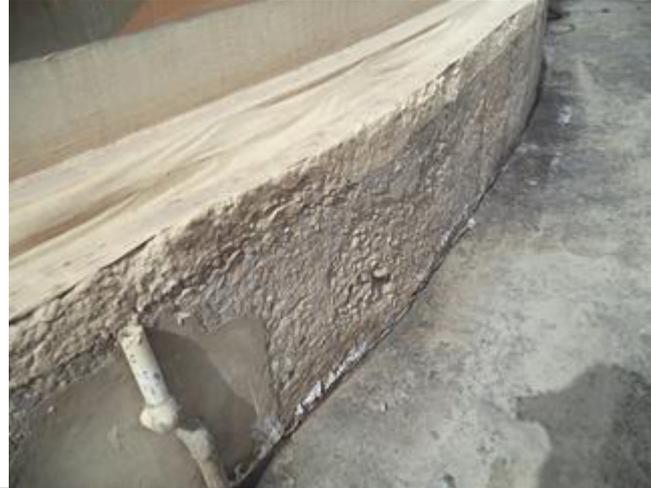
3. Tank Foundation	Spalling, minor cracks and broken concrete observed all around the foundation	<ul style="list-style-type: none"> Need to rectify by grouting 	Online Or Offline

<p>Tank Foundation</p> <p>Finding: Spalling, minor cracks and broken concrete observed all around the foundation</p> <p>Recommendation: Need to rectify by grouting</p> <p>Repair Priority: <i>Online Or Offline</i></p>

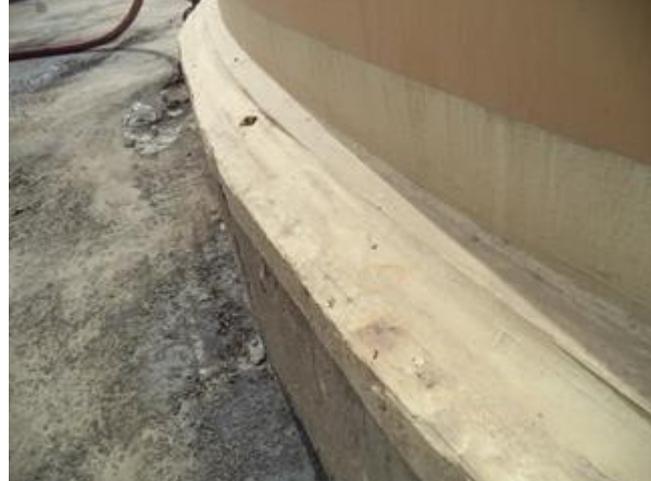
4. Bottom Projection Plate and Foundation	Projection plate and 2" lower first shell course found covered with tap coating, shell to bottom weld joint not inspected externally due to tap coating	<ul style="list-style-type: none"> Need to expose the above mention area in order to avoid corrosion under tap coating 	Offline

<p>Bottom Projection Plate and Foundation</p> <p>Finding: Projection plate and 2" lower first shell course found covered with tap coating, shell to bottom weld joint not inspected externally due to tap coating</p> <p>Recommendation: Need to expose the above mention area in ordered to avoid corrosion under tap coating</p> <p>Repair Priority: <i>Offline</i></p>

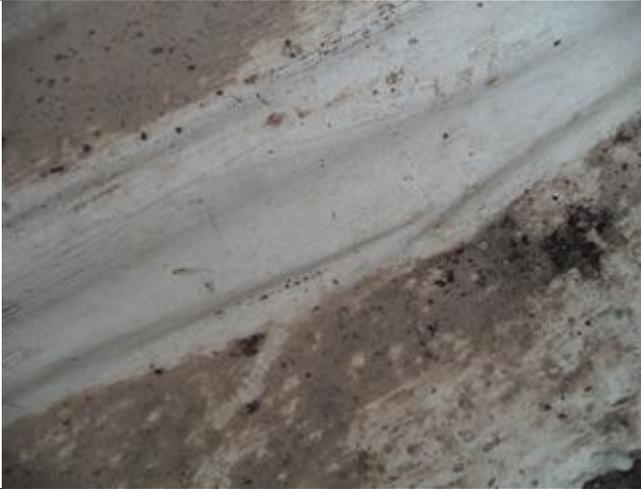
5. Bottom Projection Plate	UTG of projection plate not performed due to tap coating	<ul style="list-style-type: none"> Need to expose the projection plate in order to avoid corrosion under tap coating 	Offline

Finding:
 UTG of projection plate not performed due to tap coating
Recommendation:
 Need to expose the projection plate in ordered to avoid corrosion under tap coating
Repair Priority: *Offline*

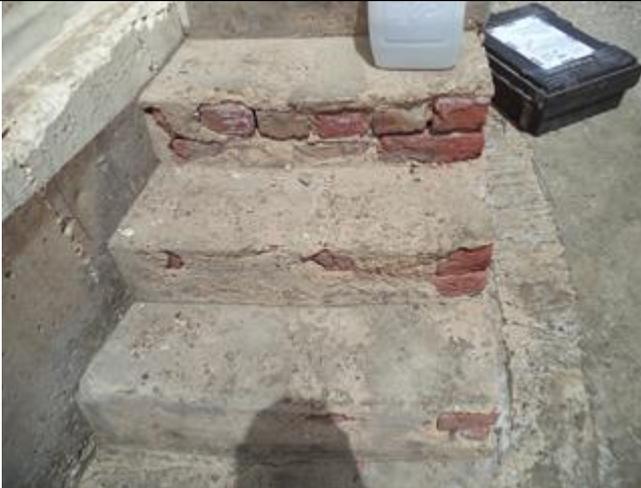
6. Concrete Steps of stairway	Spalling, minor cracks and broken concrete observed on cemented staircase steps	<ul style="list-style-type: none"> Need to refurbished as per project specification 	Online

Finding:
 Spalling, minor cracks and broken concrete observed on cemented staircase steps
Recommendation:
 Need to refurbished as per project specification
Repair Priority: *Online*

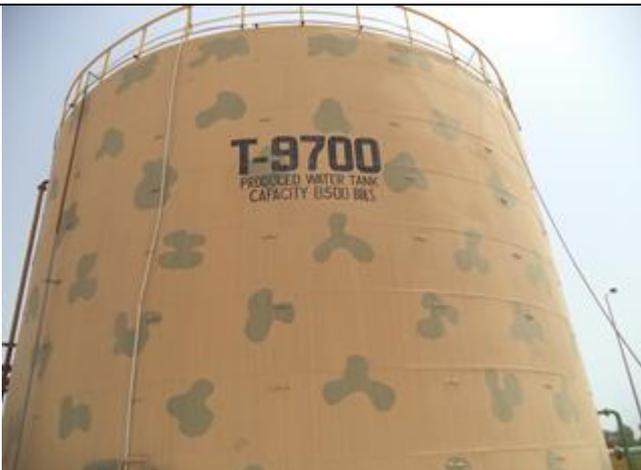
Finding:
 Name plate not found on the tank shell, however identification and other details found printed on tank shell.

Recommendation:
 Need to install name plate as per section 13.2 of API 653
Repair Priority: *Offline*

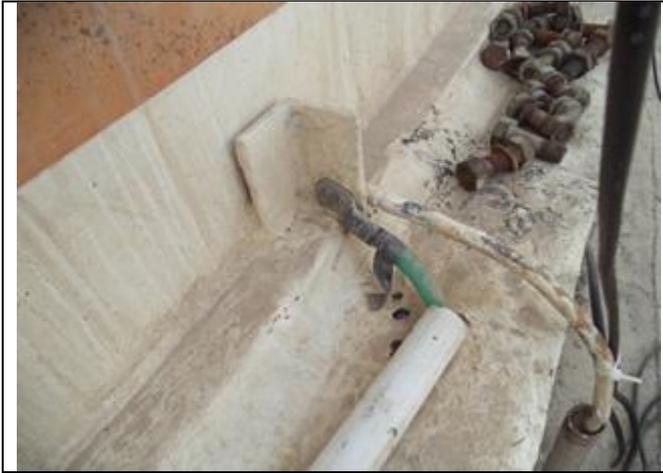
Tank Earthing

The Earthing bosses have been observed on two locations on tank shell without values of electrical resistance up to date written on them

Electrical resistance of each earthing boss should be checked on annual basis & current readings with date should be displayed on shell plates and maintained in log book

Repair Priority: *Online*

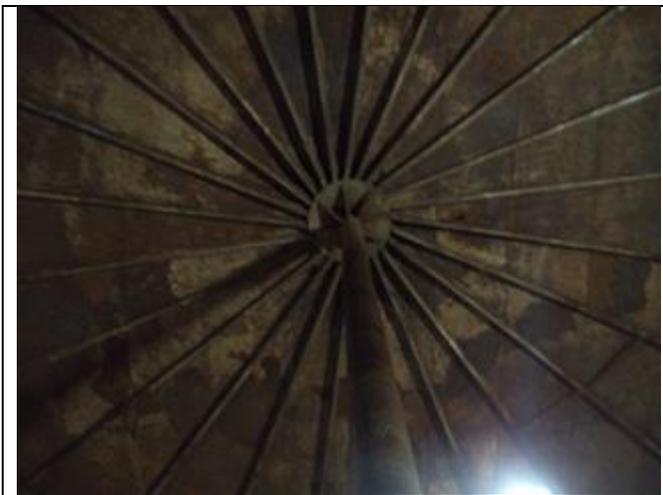
Item	Findings	Recommendations	Repair Priority
1. Internal Roof plate	scaling observed on internal side roof plate and supporting structure,	<ul style="list-style-type: none"> to made good surface perparation and recoat as per paint manufacturer' specification. 	Offline

scaling observed on internal side roof plate and supporting structure,

To made good surface perparation and recoat as per paint manufacturer' specification.

Repair Priority: *Offline*

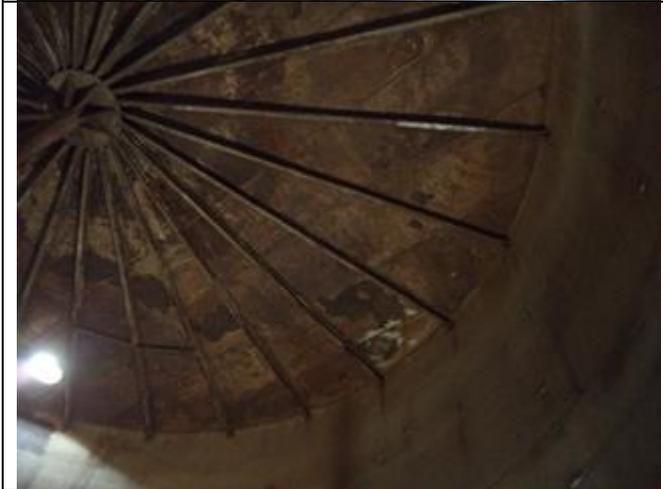
Internal Roof plate

same above

Same above

Repair Priority: *Offline*

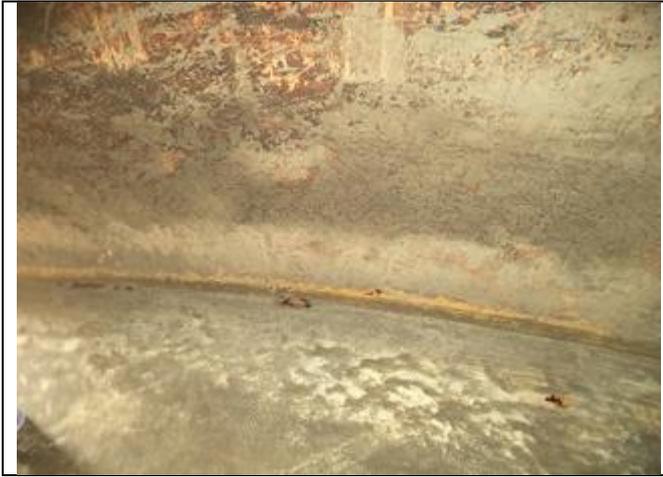
Shell to bottom weld joint

Internally shell to bottom weld joint not inspected due to FRP coating

Nil, just for info

Repair Priority: N/A
